# Philadelphia Museum of Art

## Examination and Treatment Report

**Accession #:** 1932.45.101 abc  
**Object:** Chest-on-chest-on-chest  
**Object Date:** 1735-1745  
**Materials:** Wood (cherry, hard pine, white cedar); copper alloy (brass)  
**Dimensions:** 6 feet 1/4 inches × 41 1/8 inches × 22 1/2 inches (183.5 × 104.5 × 57.2 cm)  
**Geography:** Philadelphia, Pennsylvania, United States, North and Central America  
**Curatorial Dept.:** American Art  
**Examined by:** Jonathan Stevens, Graduate Intern  
**Consulted:** Behrooz Salimnejad, Senior Conservator of Furniture, PMA  
Peggy Olley, Associate Conservator of Furniture, PMA  
Jason Wierzbicki, Conservation Photographer  
**Report Date:** February 2021

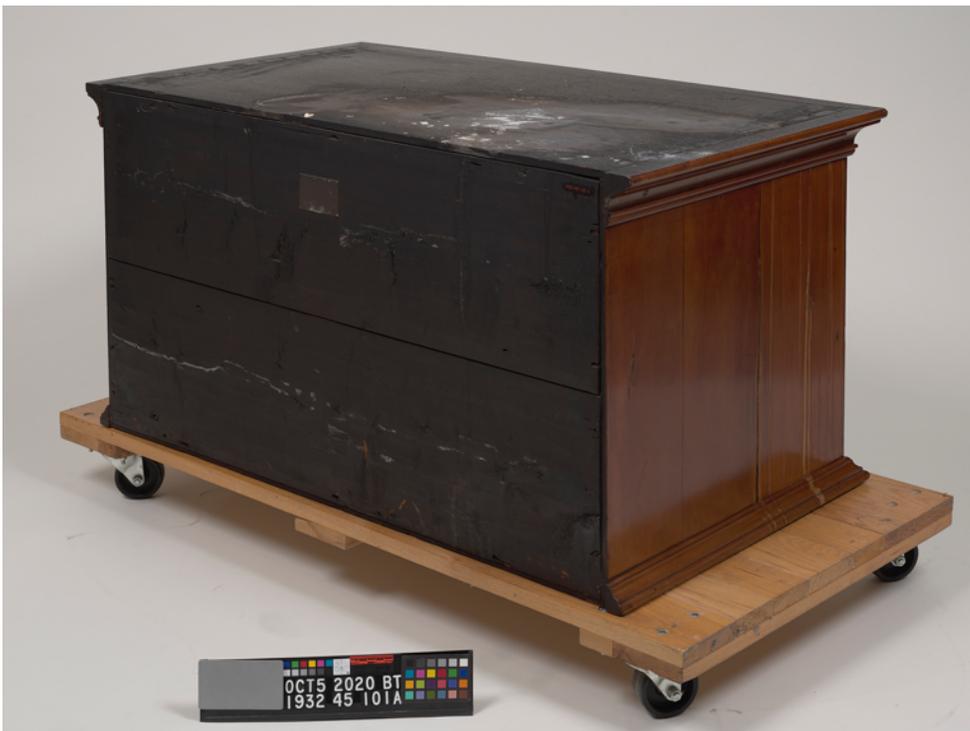
The chest is generally structurally stable with normal signs of age and wear, including repairs and refinishing. A roof leak at Cedar Grove has caused water damage to the top, the PR case side, and the PR side of the case front.

- As noted above, a roof leak has caused water damage to the top, the PR case side, and the PR side of the case front. There is also some plaster dust on the top and some staining and salt accretions within the case; water damage on case exterior has resulted in rivulets of finish loss with tidelines.

**Figure 2.** Upper case: back, top, and PR, before treatment. (Photo by Jason Wierzbicki)

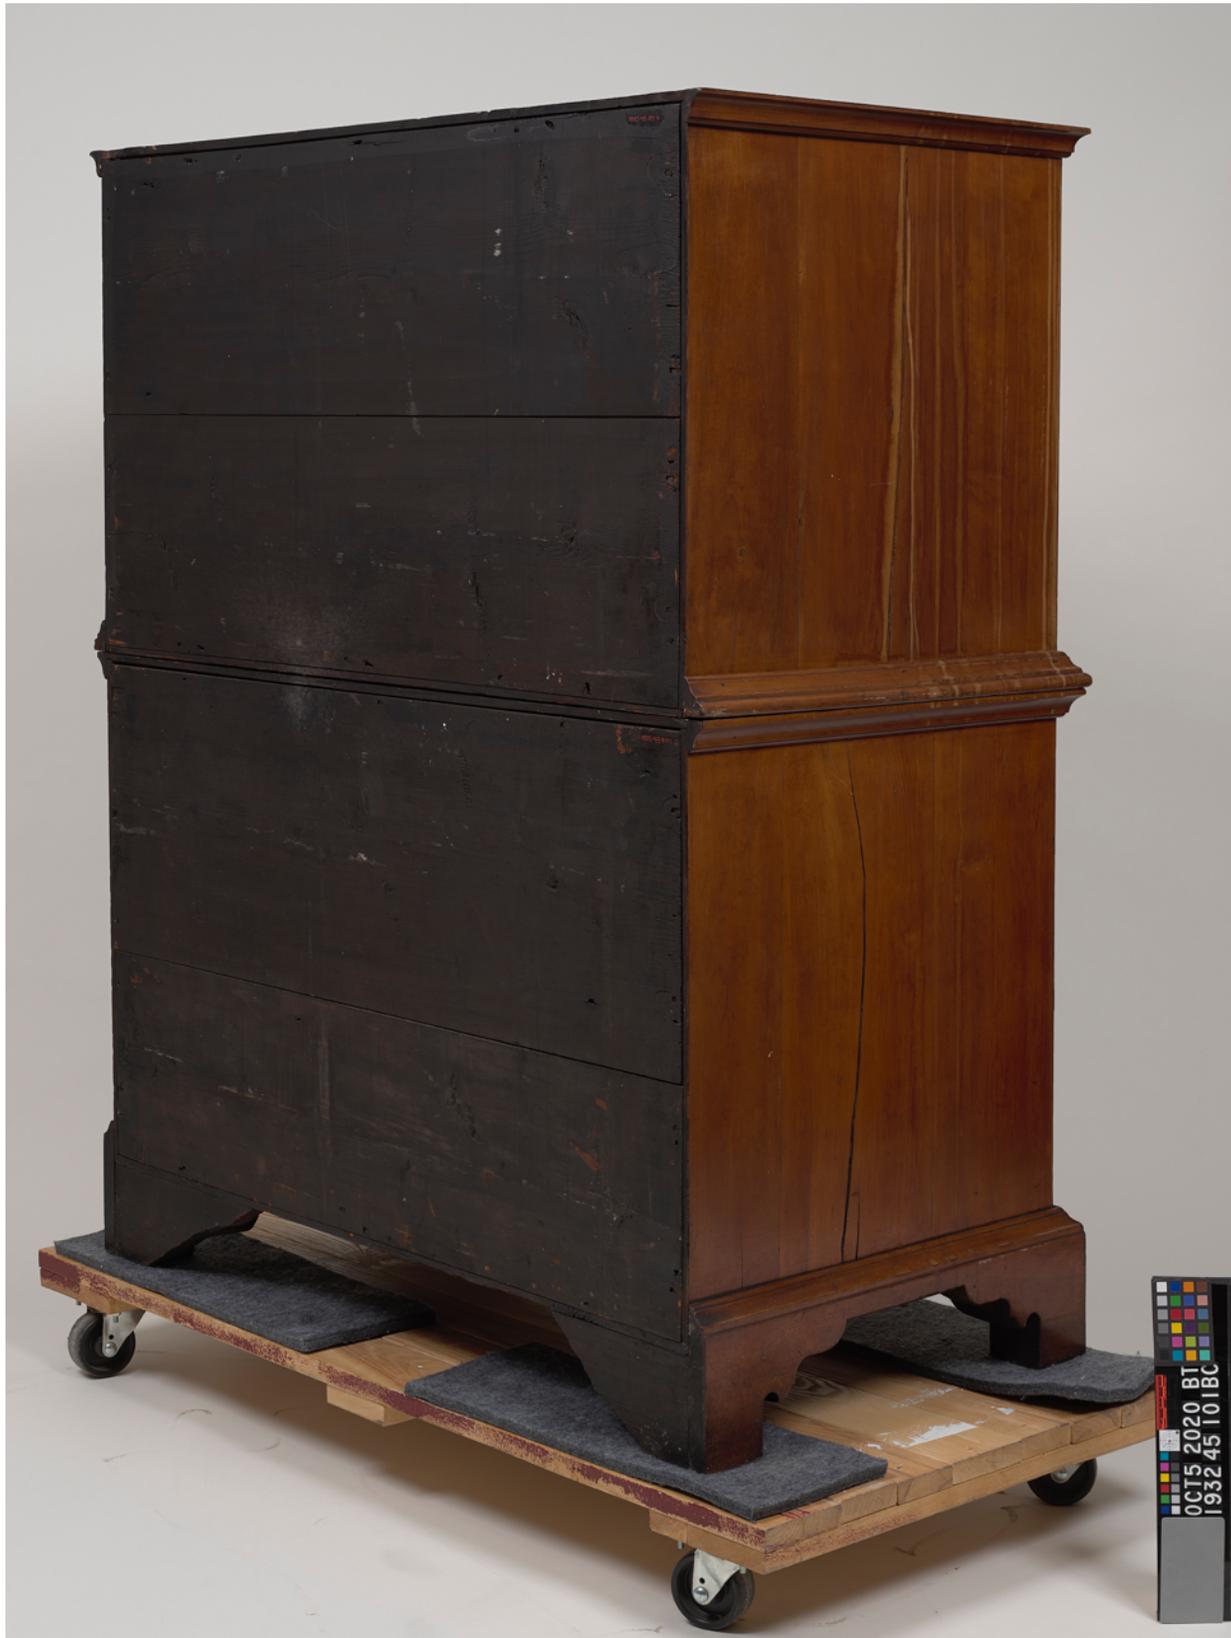
**Figure 4.** Middle and lower cases: back and PR, before treatment. (Photo by Jason Wierzbicki)

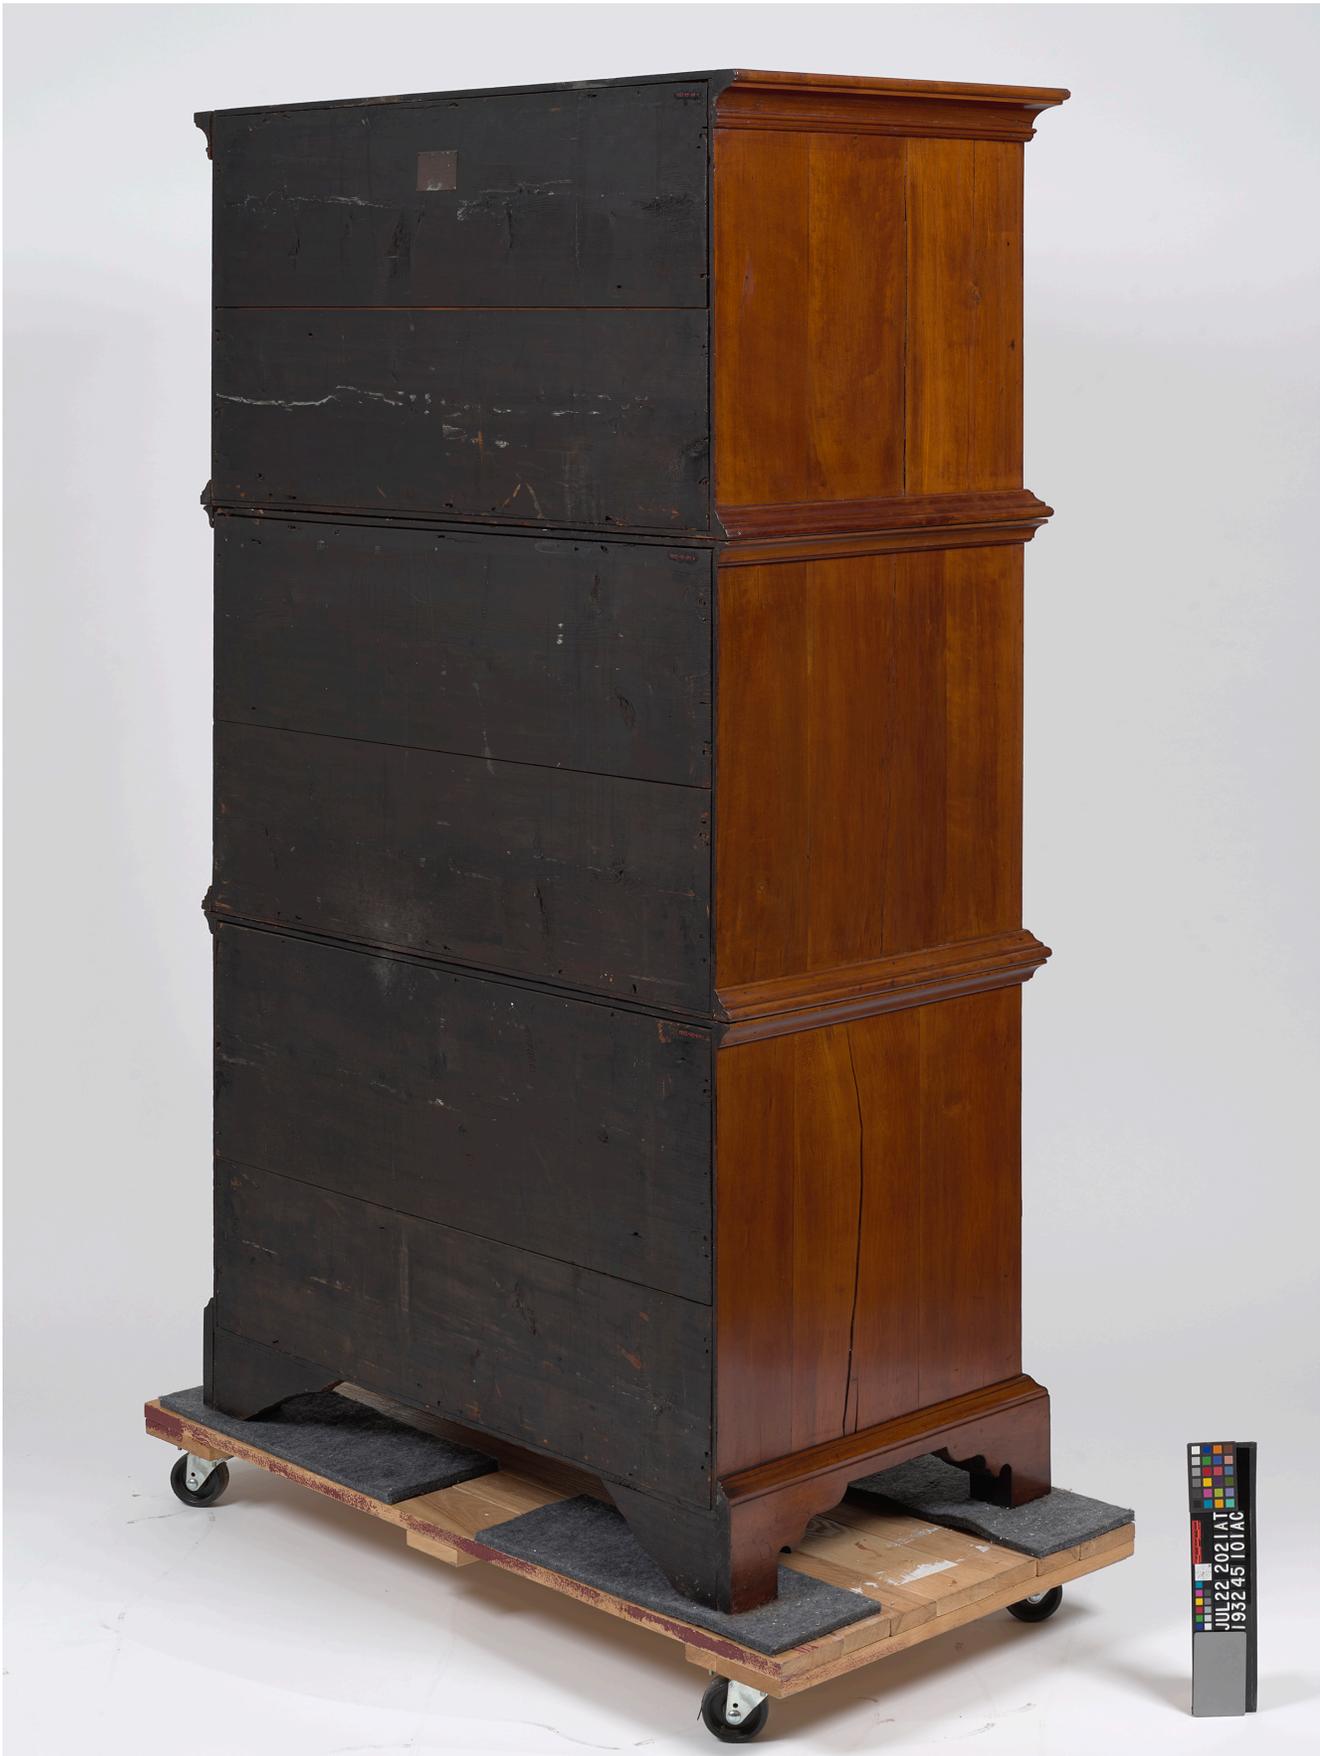
**Figure 10.** Back and PR side, after treatment. (Photo by Jason Wierzbicki)

10. Because the PR side of the triple chest (where the major water damage occurred) had also been sun-damaged and lightened noticeably overall in comparison to the rest of the chest, the entire PR side was given a light application of Regalrez 1094 applied by wiping with Kimwipe. Any excess on the surface was removed by wiping with a clean Kimwipe. This had the effect of saturating the entire surface, bringing it much closer in depth of color to the other show surfaces of the chest. This overall treatment also had the effect of further blending the water damaged areas with the rest of the finish and reduced their prominence noticeably.

14. Light areas related to water damage were toned using Gamblin conservation colors in 4:1 ethanol: diacetone OH. I was able to blend the surface much more sympathetically using the Gamblin colors, and I found the transparent earth colors especially effective. Colors were applied in small vertical strokes by brush. Once dry, these areas were varnished with Regalrez 1094 applied by brush to saturate the surface; following application, Regalrez was re-brushed as it dried to reduce the surface sheen.

15. On one area of the lower moulding of the upper chest on the PR case side and on an area of the case side above this, the finish had been almost completely removed down to bare wood, and there was a significant and noticeable dimensional difference between this area and the surrounding finish. The bare wood also darkened significantly compared with the surrounding surface, even with application of the higher molecular weight B-72 acrylic resin. The area was sized with several coats of B-72 10% in A100 as a barrier layer, then the finish was built up with successive coats of orange shellac in ethanol. Although shellac can crosslink over time, I hope that if it does become insoluble in the future that it can still be undercut by acetone or aromatics to activate the B-72 barrier layer below. I also felt more comfortable using shellac in this instance because the area was a site of nearly complete finish loss and also because the entire piece has been previously stripped and refinished with a synthetic varnish. I would be more hesitant about using shellac over an original or historic surface. Once the surface had been built up, the area was carefully polished and smoothed using micromesh paper until it was close in texture and sheen to the surrounding area. Because this area had darkened significantly, I inpainted using Gamblin colors to lighten the tone. By following the existing wood grain and using brighter opaque colors and then toning using transparent applications, I was able to arrive at an appearance that was close to the appearance of the surrounding surface. The area was then varnished using Regalrez and re-brushed to control sheen as described above.
