# Philadelphia Museum of Art

## Examination and Treatment Report

**Accession #:** 1932.45.101 abc  
**Object:** Chest-on-chest-on-chest  
**Object Date:** 1735-1745  
**Materials:** Wood (cherry, hard pine, white cedar); copper alloy (brass)  
**Dimensions:** 6 feet 1/4 inches × 41 1/8 inches × 22 1/2 inches (183.5 × 104.5 × 57.2 cm)  
**Geography:** Philadelphia, Pennsylvania, United States, North and Central America  
**Curatorial Dept.:** American Art  
**Examined by:** Jonathan Stevens, Graduate Intern  
**Consulted:** Behrooz Salimnejad, Senior Conservator of Furniture, PMA  
Peggy Olley, Associate Conservator of Furniture, PMA  
Jason Wierzbicki, Conservation Photographer  
**Report Date:** February 2021

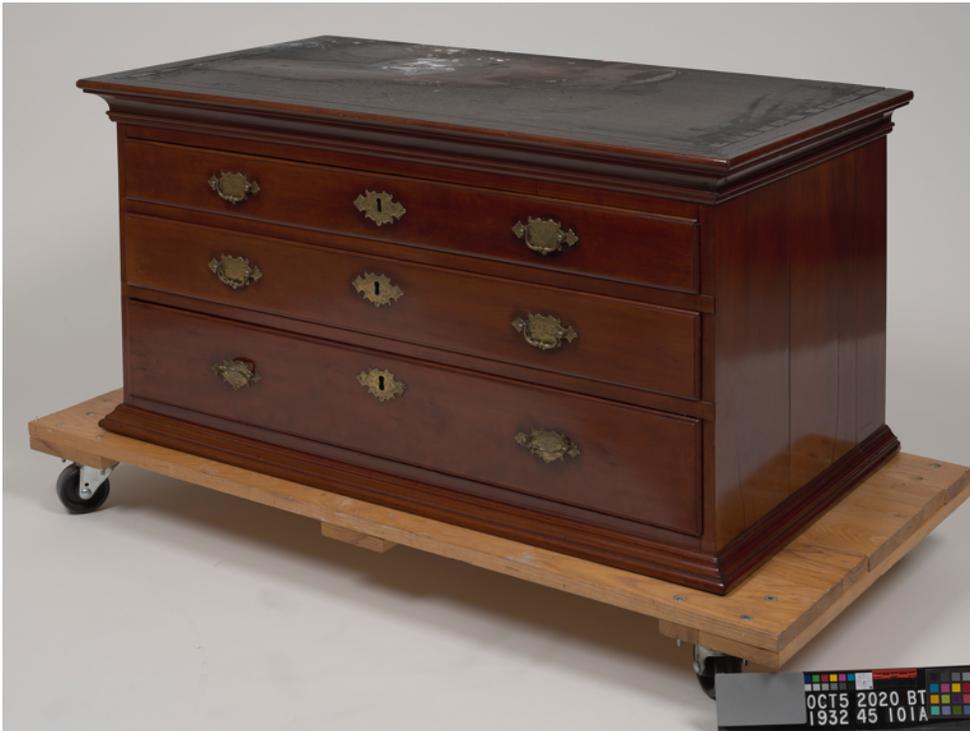
The chest is generally structurally stable with normal signs of age and wear, including repairs and refinishing. A roof leak at Cedar Grove has caused water damage to the top, the PR case side, and the PR side of the case front.

- As noted above, a roof leak has caused water damage to the top, the PR case side, and the PR side of the case front. There is also some plaster dust on the top and some staining and salt accretions within the case; water damage on case exterior has resulted in rivulets of finish loss with tidelines.

**Figure 1.** Upper case: front, top, and PL, before treatment. (Photo by Jason Wierzbicki)

4. Staining and accretions of plaster from water event were cleaned from top of chest using de-ionized water and a micro-fiber cloth. The dark finish that had been applied to the top and back had been disrupted by the leak and was partially removed in cleaning, leaving an uneven surface. This finish was likely not an original application; since the top of the chest is not visible in normal display, the disturbance of the surface was not compensated for.

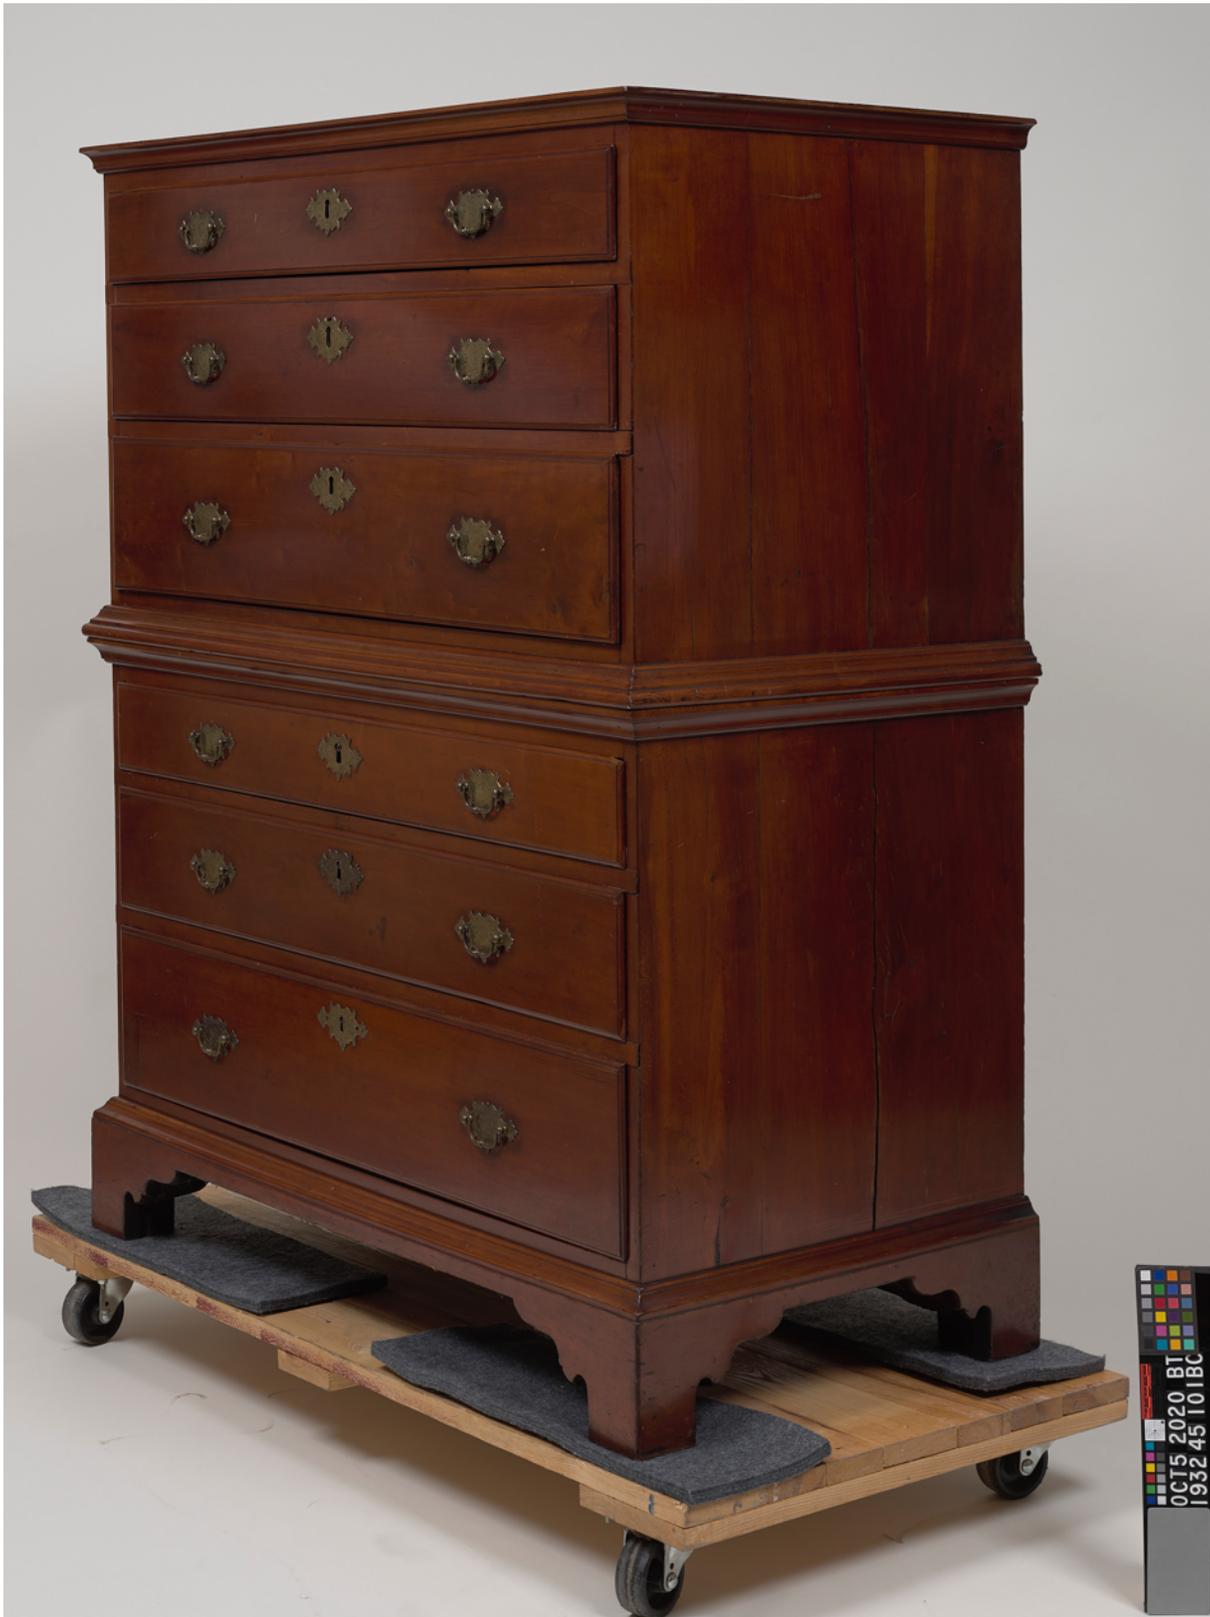
**Figure 3.** Middle and lower cases: front and PL, before treatment. (Photo by Jason Wierzbicki)

3. Loose drawer runner at PL side of lowest drawer opening was re-glued using cold fish glue and weighted using beanbag snakes. Fish glue was chosen because it can be used readily without heating and is somewhat more reversible than hot hide glue.

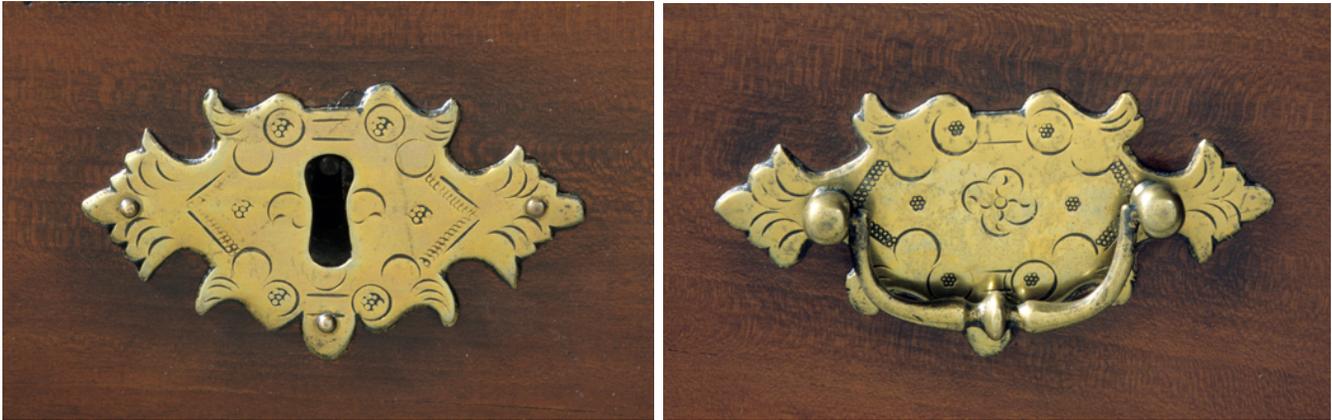
- Scribe lines do not align with current drawer locks, and many drawer locks fit poorly; likely replacements.
- Keyhole escutcheon on eighth drawer from top is made from thicker brass and has sharper detail and a different tone than other hardware; likely replacement.

**Figure 7.** Escutcheon and drawer pull from 1932.45.101abc. (PMA photo studio)

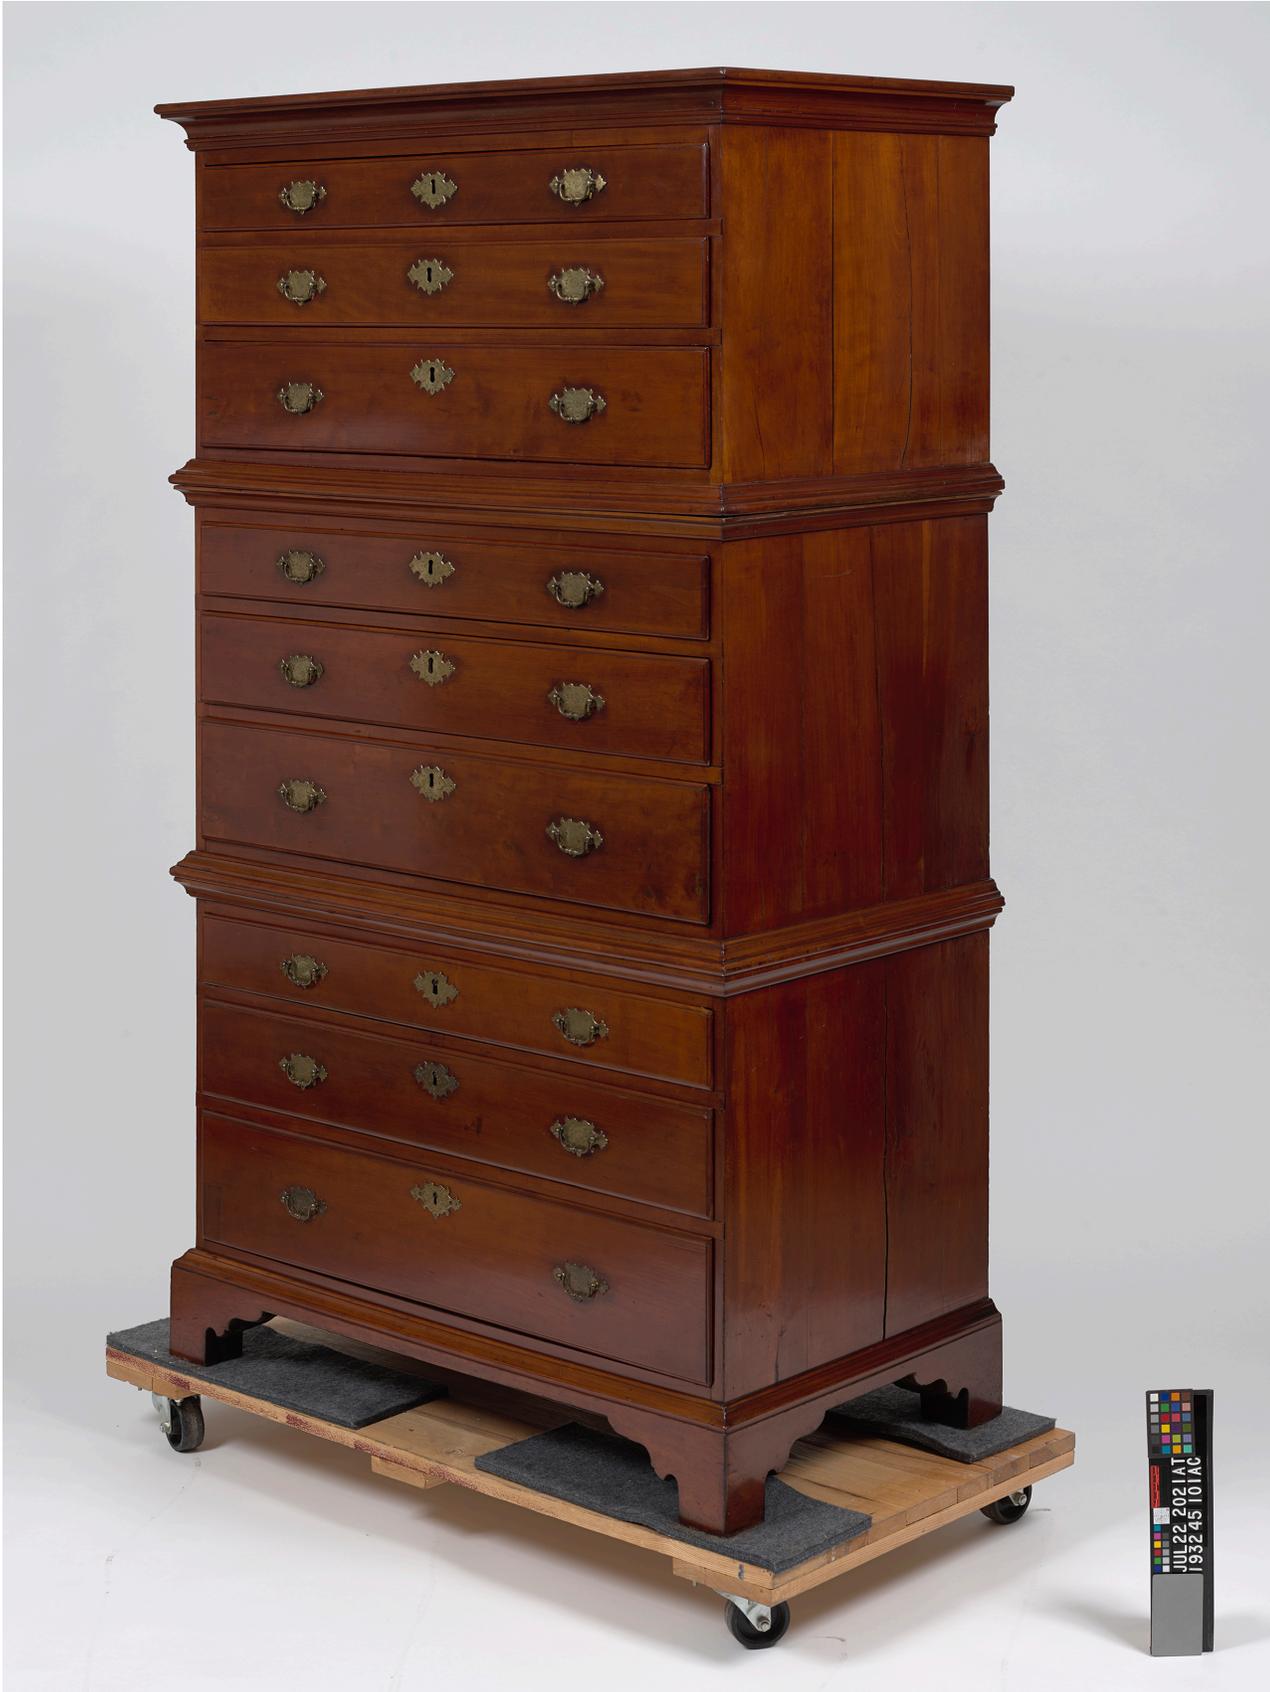
**Figure 9.** Front and PL side, after treatment. (Photo by Jason Wierzbicki)
